The repairable **BODY LINER**

THE ADVANTAGES OF PUCEST BODY LINER

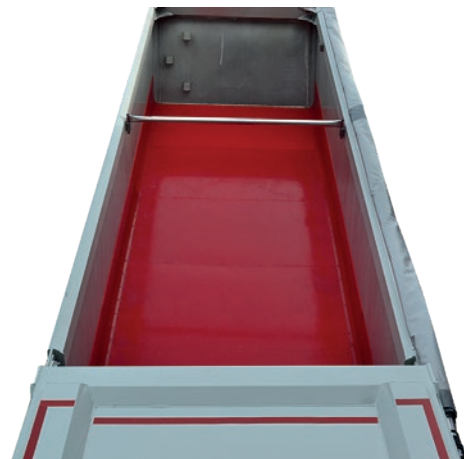
The repairable PUCEST body Liner can be delivered in any desired design. The lining consists of perforated plate segments that can be screwed, edged and also can be rolled. Later possible washouts may be repaired at any time using PUCEST TIX.

The sheets can be delivered using perforated steel sheet device or using light and by hand deformable aluminum plate devices

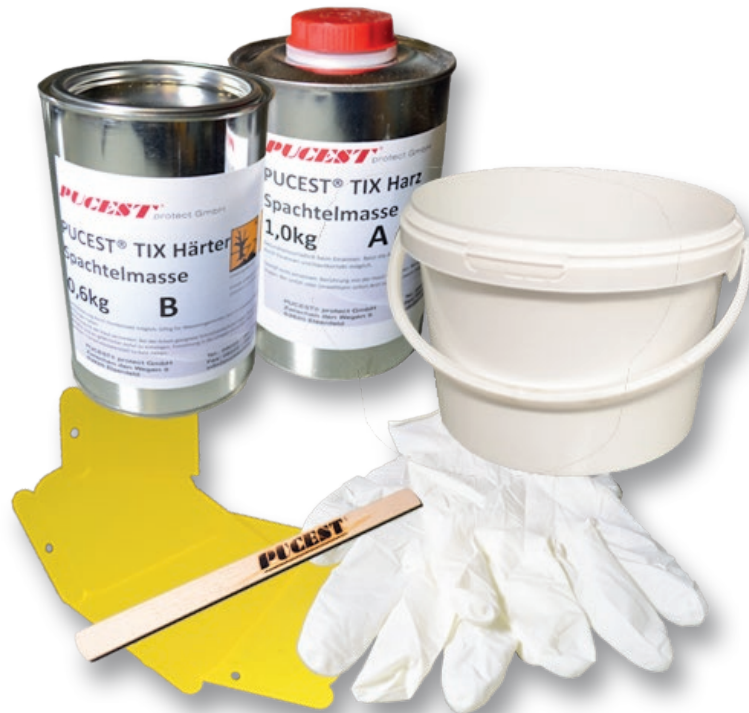
PUCEST TIX

PUCESTTix was developed specifically for the repair of worn PUCEST - wear protective systems.

Conventional wear solutions made it usually necessary to replace the entire wear surface by low tear and wear. Since PUCEST Tix was developed this is no longer required, because damaged spots can be repaired.
